NASA
Technical
Paper
2406

AVSCOM
Technical
Report
84-C-17

High-Temperature Erosion
of Plasma-Sprayed,
Yttria-Stabilized
Zirconia in a Simulated
Turbine Environment

Robert F. Handschuh

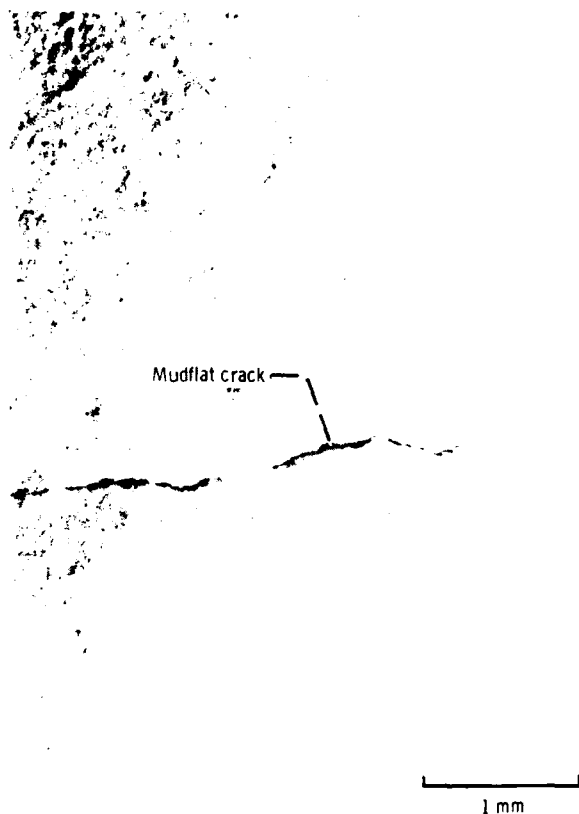
Figure 16.—SEM photograph showing preferential erosion in zone near mudflat crack. Specimen eroded at 12.7-cm (5-in.) downstream distance and 90° impingement angle.

The remaining specimens to be discussed had surfaces that were eroded. Three different specimens (figs. 15 to 17) exposed to the erosive medium at 12.7 and 10.2 cm (5 and 4 in.) downstream of the nozzle exit plane with a 90° impingement angle were examined in the SEM. The surfaces had randomly distributed and oriented markings that indicated particle edge and flat side impacts. Presumably this was caused by the grit material having sharp, well-defined edges (90° typically from one face to the next) along with very flat surfaces between these edges (fig. 6). Also some surface material had been melted and then reattached to nearby surface material (fig. 15).
